South Bend 9" Model A lathe

Posted by Brett Flemming <efficientvelo@aol.com>

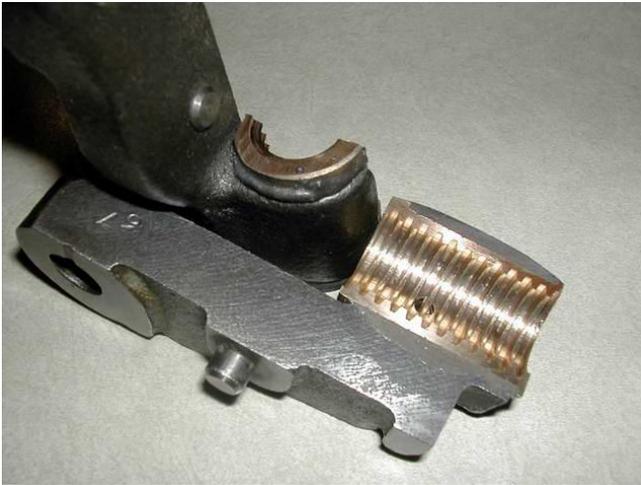
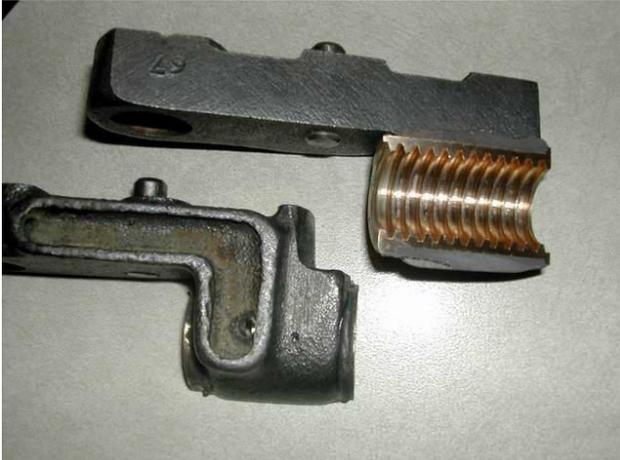
Part of my machining hobby is restoring worn machinery to usable condition and getting those machines in the hands of people who want to make chips. A recent reconstruction of a South Bend Model A involved restoring completely worn out (as in completely gone) half nut threads.

I cannot figure how these half nuts were worn out so badly on a Model A, but there was no disputing what they were. I bored out old threads to a .900" bore. Made a bearing bronze spool to .895" to allow for epoxy to fill gap and account for misalignment. Then I single pointed the threads till spool threaded on leadscrew easily. I then made few passes on the spool outside diameter at 4tpi to rough-up for epoxy to grip. I then installed the bored half-nuts on saddle, put saddle on lathe, screwed spool onto leadscrew, replaced lead screw end support to line things up, then clanked half nuts closed on spool to test fit.

Once it looked like it would work, I coated spool with epoxy, clanked half nuts closed, then let cure for a few days. I then removed saddle by running lathe screw backwards. I then drilled and roll pinned (1/16") on each end of spool lip. I then clamped the half-nut assembly in the mill vise and split it with a big slotting saw, drilled oil holes, and Voila. half nuts live again.
